**Flood Control Project Maintenance
Levee Inspections****LMA District Cover Sheet****Spring 2015 Levee Inspection Results****Reclamation District No. 0524 Middle Roberts Island**

Spring 2015 Levee Inspection Results

Reclamation District No. 0524 Middle Roberts Island

Waterway			Bank	Unit Miles
Unit No. 01 San Joaquin River			Left	6.20
	Spring (March - May)	Summer (June - August)	(September - November) Fall	Winter (December - February)
Unit Maintenance Rating (Fall Only)				
Date of Inspection	04/21/2015 - 04/21/2015			
DWR Inspector	Richard Willoughby			
Accompanied By	Mario Jaques RD 524

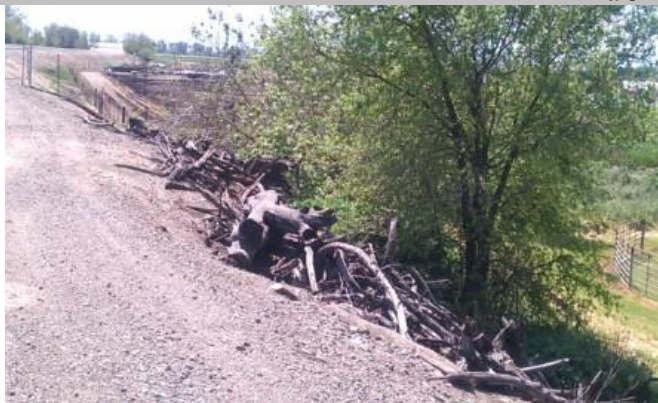
Photo 1 of 1 : SP_2015_RD0524_107_50_20150309_00072.jpg

LM Start	2.90	Rating **	U	Issue No.	50
LM End	2.92	Issue Type +	Ma	Location *	LS
Category	Earthen Levee			GPS Latitude/Longitude	
				Start	End
Item	Encroachments			37.913767 °	37.913503 °
				-121.324427 °	-121.324488 °
DWR ID	DWR_RD0524_01_s _ 2012_50				
Action/Comments					
Prunings

Looking southwest at prunings on landside slope.

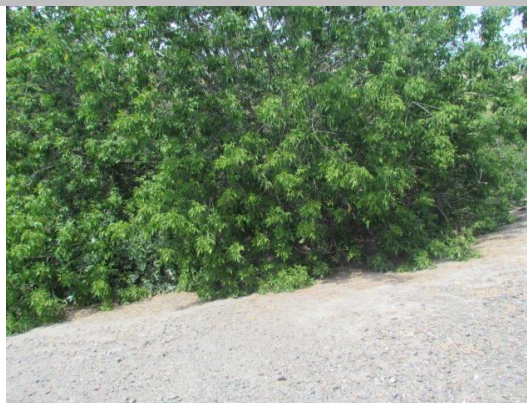
Photo 1 of 1 : SP_2015_RD0524_107_51_20150424_00220.jpg

LM Start	2.93	Rating **	M	Issue No.	51
LM End	2.93	Issue Type +	Ma	Location *	LS
Category	Earthen Levee			GPS Latitude/Longitude	
				Start	End
Item	Trim / Thin Trees			37.913415 °	37.913415 °
				-121.324503 °	-121.324503 °
DWR ID	DWR_RD0524_01_s _ 2012_51				
Action/Comments					
Trim trees to at least five feet above ground level.

Looking south at dense trees on landward slope.

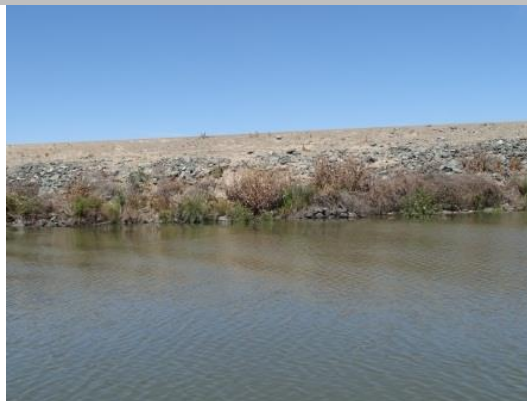
Photo 1 of 1 : SP_2015_RD0524_107_193_20150309_00154.jpg

LM Start	2.96	Rating **	U	Issue No.	193
LM End	2.96	Issue Type +	Ma	Location *	WS
Category	Supplemental			GPS Latitude/Longitude	
				Start	End
Item	DWR Erosion Survey			37.913010 °	37.913010 °
				-121.324490 °	-121.324490 °
DWR ID	DWR_RD0524_01_s _ 2015_193				
Action/Comments					
Inspector Comments: 6/19/2014: No significant change observed. 08/13/2013: No significant change observed. 08/07/2012: The site was first reported in 2012 spring levee inspection report. [2014 Site ID:RD0524U01RM43.52]

Front view of the erosion.

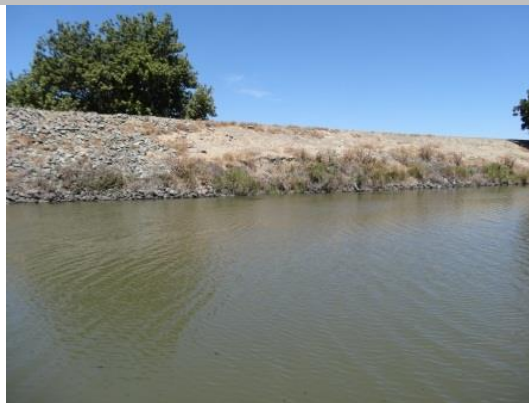
Photo 1 of 1 : SP_2015_RD0524_107_5_20150309_00010.jpg

LM Start	3.31	Rating **	U	Issue No.	5
LM End	3.31	Issue Type +	Ma	Location *	WS
Category	Supplemental			GPS Latitude/Longitude	
				Start	End
Item	DWR Erosion Survey			37.908090 °	37.908090 °
				-121.325090 °	-121.325090 °
DWR ID	DWR_RD0524_01_s _ 2015_5				
Action/Comments					
Inspector Comments: 6/19/2014: No significant change observed. 08/13/2013: The levee toe seems to have been protected by river rocks and vegetation on site. [2014 Site ID:RD0524U01RM43.86]

View from upstream of the erosion.

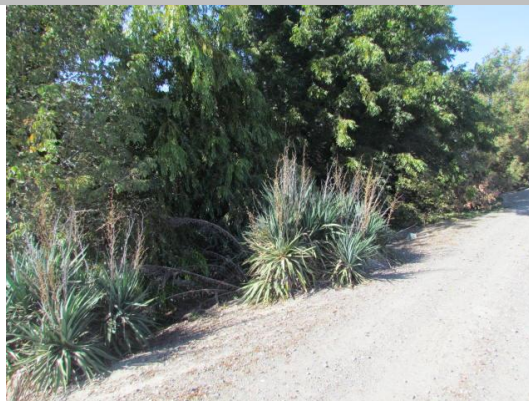
Photo 1 of 1 : SP_2015_RD0524_107_54_20150309_00073.jpg

LM Start	3.40	Rating **	U	Issue No.	54
LM End	3.45	Issue Type +	Ma	Location *	LS
Category	Earthen Levee			GPS Latitude/Longitude	
				Start	End
Item	Trim / Thin Trees			37.906747 °	37.906192 °
				-121.325248 °	-121.324543 °
DWR ID	DWR_RD0524_01_s _ 2012_54				
Action/Comments					
Trim and thin trees to allow visibility of the ground and room to flood fight.

Looking northwest at dense vegetation on landside slope.

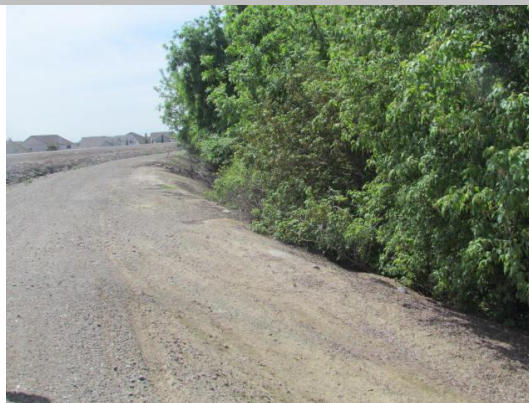
Photo 1 of 1 : SP_2015_RD0524_107_57_20150309_00076.jpg

LM Start	3.51	Rating **	U	Issue No.	57
LM End	3.61	Issue Type +	Ma	Location *	LS
Category	Earthen Levee			GPS Latitude/Longitude	
				Start	End
Item	Trim / Thin Trees			37.905638 °	37.904430 °
				-121.323892 °	-121.324570 °
DWR ID	DWR_RD0524_01_s_2012_57				
Action/Comments					
Trim and thin trees to allow visibility of the ground and room to flood fight.

Looking south at dense trees on landward slope.

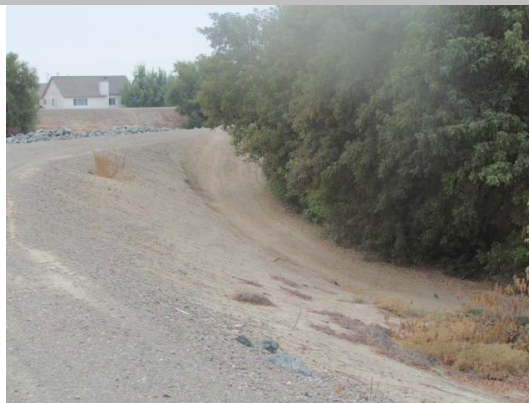
Photo 1 of 1 : SP_2015_RD0524_107_265_20150309_00159.jpg

LM Start	3.51	Rating **	M	Issue No.	265
LM End	3.51	Issue Type +	En	Location *	LS
Category	Earthen Levee			GPS Latitude/Longitude	
				Start	End
Item	Encroachments			37.905552 °	37.905552 °
				-121.323847 °	-121.323847 °
DWR ID	DWR_RD0524_01_s_2012_265				
Action/Comments					
Ramp					
Inspector Comments: Unauthorized ramp on landside slope.

Looking southeast at unauthorized ramp on landside slope and toe.

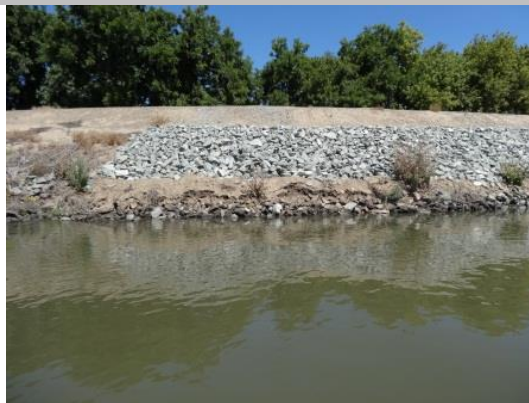
Photo 1 of 1 : SP_2015_RD0524_107_55_20150309_00074.jpg

LM Start	3.57	Rating **	M	Issue No.	55
LM End	3.57	Issue Type +	Ma	Location *	WS
Category	Supplemental			GPS Latitude/Longitude	
				Start	End
Item	DWR Erosion Survey			37.904630 °	37.904630 °
				-121.323610 °	-121.323610 °
DWR ID	DWR_RD0524_01_s _ 2015_55				
Action/Comments					
Inspector Comments: 6/19/2014: The previous erosion was repaired. New erosion was found below the repaired levee slope. 08/13/2013: No significant change observed. 08/07/2012: The levee toe has been cut off along a 150 ft. long river stretch. The erosion is located just upstream of a river bend. [2014 Site ID:RD0524U01RM44.13]

View of the repaired site.

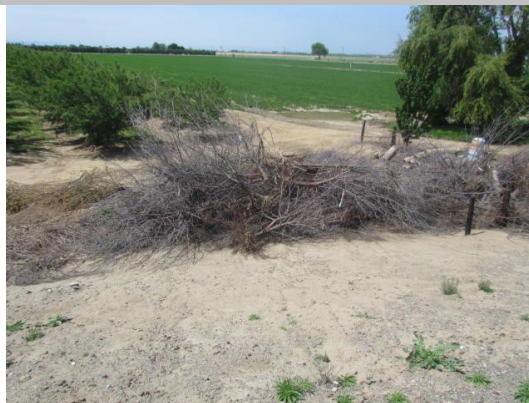
Photo 1 of 1 : SP_2015_RD0524_107_192_20150424_00222.jpg

LM Start	3.67	Rating **	U	Issue No.	192
LM End	3.67	Issue Type +	Ma	Location *	LS
Category	Earthen Levee			GPS Latitude/Longitude	
				Start	End
Item	Encroachments			37.903782 °	37.903782 °
				-121.325363 °	-121.325363 °
DWR ID	DWR_RD0524_01_s_2015_192				
Action/Comments					
Prunings					
Inspector Comments: Large pruning piles at landward toe.

Looking east at pruning pile at landward toe.

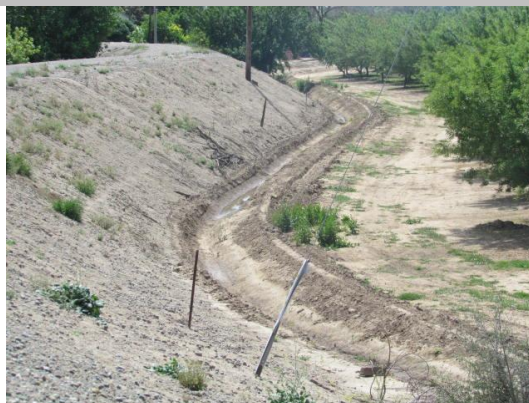
Photo 1 of 2 : SP_2015_RD0524_107_194_20150424_00223.jpg

LM Start	3.69	Rating **	M	Issue No.	194
LM End	3.78	Issue Type +	En	Location *	LS
Category	Earthen Levee			GPS Latitude/Longitude	
				Start	End
Item	Encroachments			37.903553 °	37.902505 °
				-121.325468 °	-121.326425 °
DWR ID	DWR_RD0524_01_s_2015_194				
Action/Comments					
Ditch					
Inspector Comments: Irrigation ditch at landward toe.

Looking south at irrigation ditch at landward toe.

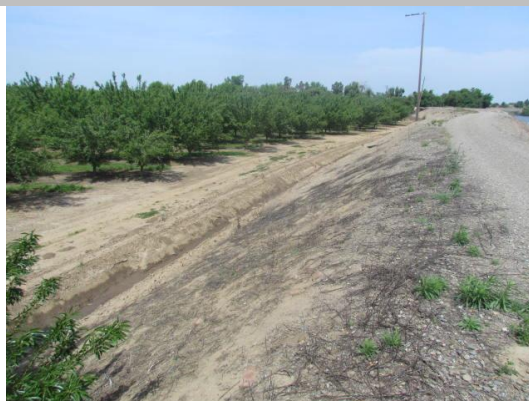
Photo 2 of 2 : SP_2015_RD0524_107_194_20150424_00224.jpg

Looking east at south end of irrigation ditch at landward toe.

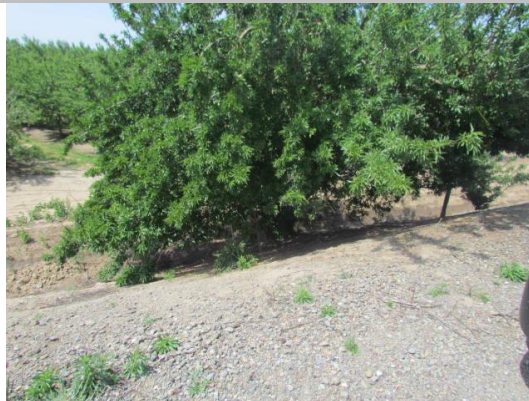
Photo 1 of 1 : SP_2015_RD0524_107_927_20150424_00225.jpg

Looking east at untrimmed tree on landward slope.

LM Start	3.77	Rating **	M	Issue No.	927
LM End	3.77	Issue Type +	Ma	Location *	LS
Category	Earthen Levee			GPS Latitude/Longitude	
				Start	End
Item	Trim / Thin Trees			37.902645 °	37.902645 °
				-121.326340 °	-121.326340 °
DWR ID	DWR_RD0524_01_s _ 2012_927				
Action/Comments					
Trim trees to at least five feet above ground level.

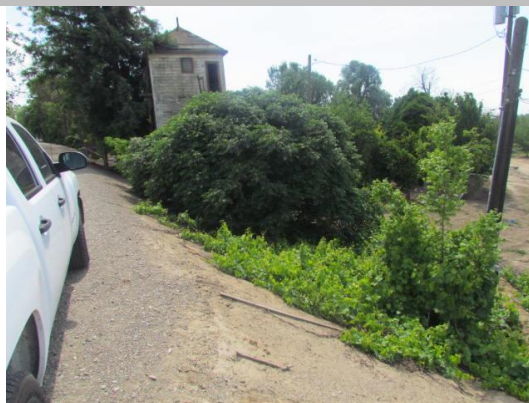
Photo 1 of 1 : SP_2015_RD0524_107_59_20150424_00226.jpg

Looking south at untrimmed trees on landward slope.

LM Start	3.78	Rating **	M	Issue No.	59
LM End	3.78	Issue Type +	Ma	Location *	LS
Category	Earthen Levee			GPS Latitude/Longitude	
				Start	End
Item	Trim / Thin Trees			37.902417 °	37.902417 °
				-121.326482 °	-121.326482 °
DWR ID	DWR_RD0524_01_s _ 2012_59				
Action/Comments					
Trim trees to at least five feet above ground level.

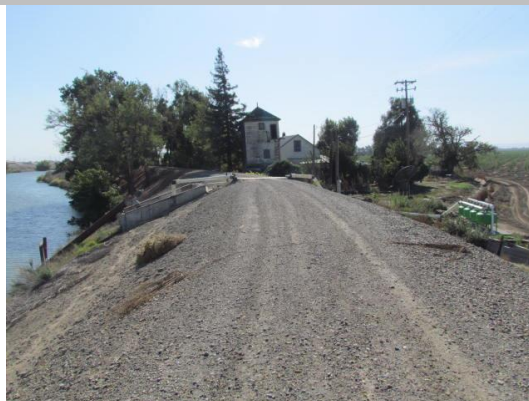
Photo 1 of 3 : SP_2015_RD0524_107_266_20150309_00160.jpg

LM Start	3.79	Rating **	M	Issue No.	266
LM End	3.79	Issue Type +	En	Location *	CR
Category	Earthen Levee			GPS Latitude/Longitude	
				Start	End
Item	Encroachments			37.902365 °	37.902365 °
				-121.326453 °	-121.326453 °
DWR ID	DWR_RD0524_01_s _ 2012_266				
Action/Comments					
Equipment					
Inspector Comments: Landowner installed water filter piping system without permit.

Looking south at unauthorized irrigation pipe across levee and water filtration system at landside toe.

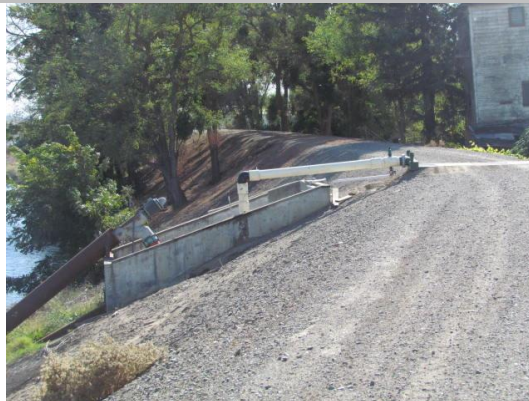
Photo 2 of 3 : SP_2015_RD0524_107_266_20150309_00161.jpg

LM Start	3.79	Rating **	M	Issue No.	266 (cont)	
LM End	3.79	Issue Type +	En	Location *	CR	
Category	Earthen Levee			GPS Latitude/Longitude		
				Start		End
Item	Encroachments			37.902365 °	37.902365 °	
				-121.326453 °	-121.326453 °	
DWR ID	DWR_RD0524_01_s _ 2012_266					
Action/Comments						
Equipment						
Inspector Comments: Landowner installed water filter piping system without permit.

Looking south unauthorized PVC irrigation pipe across the levee crown.

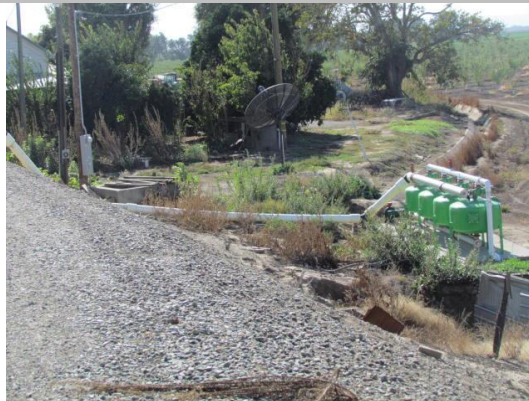
Photo 3 of 3 : SP_2015_RD0524_107_266_20150309_00162.jpg

Looking west at water filtration system on landside toe.

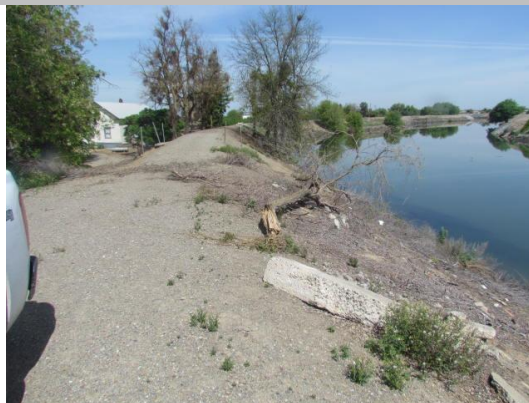
Photo 1 of 1 : SP_2015_RD0524_107_187_20150309_00152.jpg

LM Start	3.85	Rating **	M	Issue No.	187
LM End	3.85	Issue Type +	Ma	Location *	WS
Category	Earthen Levee			GPS Latitude/Longitude	
				Start	End
Item	Encroachments			37.901447 °	37.901447 °
				-121.326500 °	-121.326500 °
DWR ID	DWR_RD0524_01_s_2014_187				
Action/Comments					
Tree or limb					
Inspector Comments: Tree limb on waterward shoulder.

Looking northeast at tree limb on waterward slope.

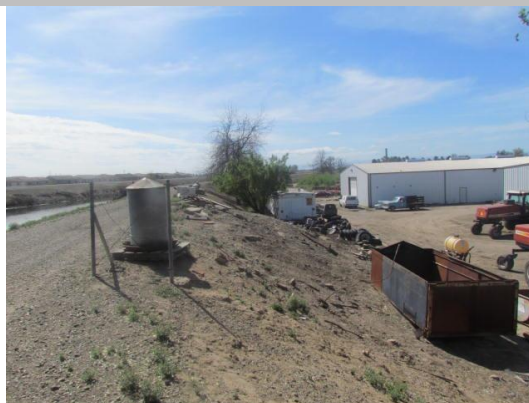
Photo 1 of 2 : SP_2015_RD0524_107_62_20150309_00078.jpg

LM Start	3.86	Rating **	M	Issue No.	62
LM End	3.97	Issue Type +	En	Location *	LS
Category	Earthen Levee			GPS Latitude/Longitude	
				Start	End
Item	Encroachments			37.901375 °	37.899745 °
				-121.326507 °	-121.326630 °
DWR ID	DWR_RD0524_01_s_2012_62				
Action/Comments					
Equipment

Looking south at northend of equipment stored at landward slope and toe.

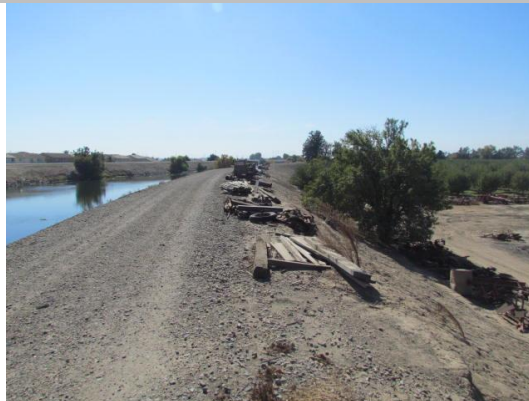
Photo 1 of 3 : SP_2015_RD0524_107_95_20150309_00100.jpg

LM Start	3.87	Rating **	U	Issue No.	95
LM End	3.90	Issue Type +	En	Location *	LS
Category	Earthen Levee			GPS Latitude/Longitude	
				Start	End
Item	Encroachments			37.901147 °	37.900735 °
				-121.326453 °	-121.326425 °
DWR ID	DWR_RD0524_01_f_2013_95				
Action/Comments					
Equipment					
Inspector Comments: Landowner is storing equipment on landward shoulder and landward toe.

Looking south at farm equipment stored on landward shoulder and toe.

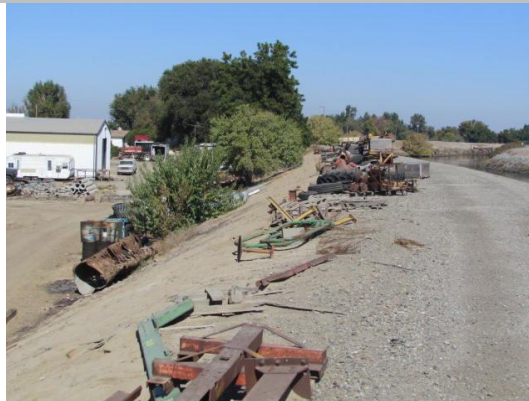
Photo 2 of 3 : SP_2015_RD0524_107_95_20150309_00101.jpg

Looking north at farm equipment stored on landward shoulder.

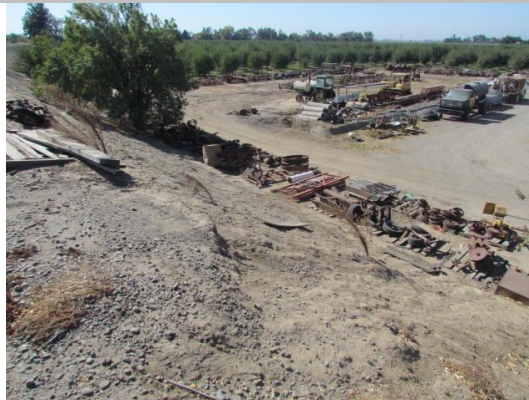
Photo 3 of 3 : SP_2015_RD0524_107_95_20150309_00102.jpg

Looking west at farm equipment stored at landward toe.

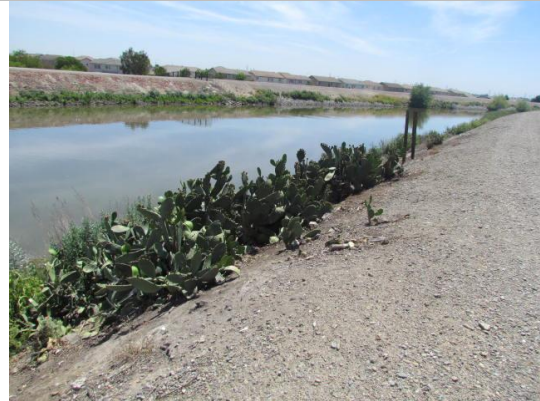
Photo 1 of 1 : SP_2015_RD0524_107_94_20150309_00099.jpg

Looking southeast at cactus on waterside slope.

LM Start	3.88	Rating **	M	Issue No.	94
LM End	3.88	Issue Type +	Ma	Location *	WS
Category	Earthen Levee			GPS Latitude/Longitude	
				Start	End
Item	Vegetation			37.900952 °	37.900952 °
				-121.326443 °	-121.326443 °
DWR ID	DWR_RD0524_01_s_2012_94				
Action/Comments					
Remove the wild growth other than native grasses from the levee slopes.					
Inspector Comments: Remove cactus

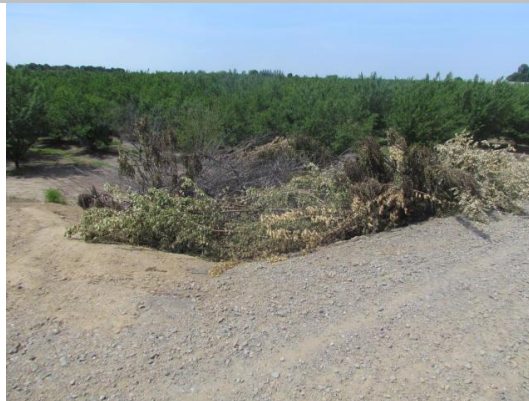
Photo 1 of 1 : SP_2015_RD0524_107_195_20150424_00227.jpg

LM Start	4.02	Rating **	U	Issue No.	195
LM End	4.02	Issue Type +	Ma	Location *	LS
Category	Earthen Levee			GPS Latitude/Longitude	
				Start	End
Item	Encroachments			37.899093 °	37.899093 °
				-121.326933 °	-121.326933 °
DWR ID	DWR_RD0524_01_s _ 2015_195				
Action/Comments					
Prunings					
Inspector Comments: Pruning pile blocking view of landward slope.

Looking east at pruning pile at landward toe.

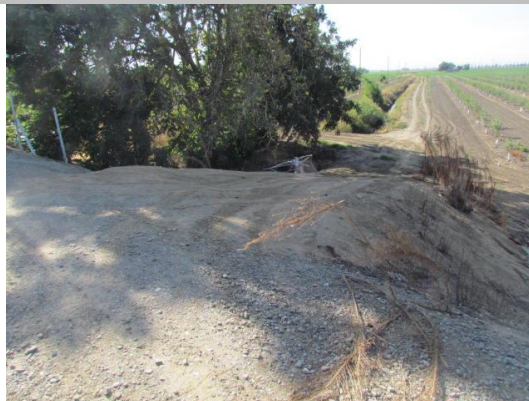
Photo 1 of 1 : SP_2015_RD0524_107_101_20150309_00104.jpg

LM Start	4.02	Rating **	U	Issue No.	101
LM End	4.02	Issue Type +	En	Location *	LS
Category	Earthen Levee			GPS Latitude/Longitude	
				Start	End
Item	Encroachments			37.899027 °	37.899027 °
				-121.326982 °	-121.326982 °
DWR ID	DWR_RD0524_01_s _ 2012_101				
Action/Comments					
Ramp Inspector Comments: Unauthorized ramp. Ramp does not meet Title 23 standard.

Looking west at unauthorized ramp on landside slope.

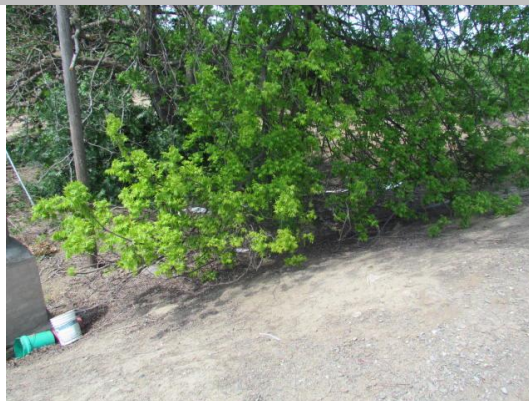
Photo 1 of 1 : SP_2015_RD0524_107_61_20150424_00228.jpg

Looking east at untrimmed tree at landward toe.

LM Start	4.03	Rating **	M	Issue No.	61
LM End	4.03	Issue Type +	Ma	Location *	LS
Category	Earthen Levee			GPS Latitude/Longitude	
				Start	End
Item	Trim / Thin Trees			37.898925 °	37.898925 °
				-121.327015 °	-121.327015 °
DWR ID	DWR_RD0524_01_s _ 2012_61				
Action/Comments					
Trim trees to at least five feet above ground level.

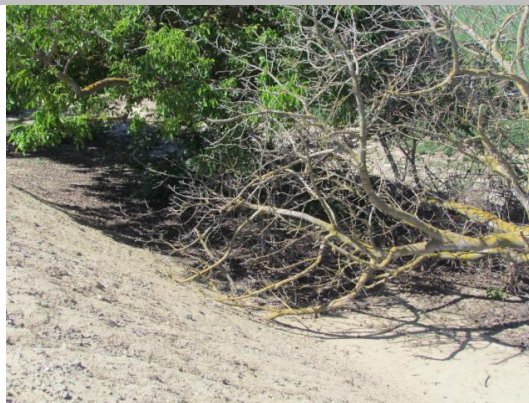
Photo 1 of 1 : SP_2015_RD0524_107_111_20150309_00116.jpg

LM Start	4.38	Rating **	M	Issue No.	111
LM End	4.38	Issue Type +	En	Location *	LS
Category	Earthen Levee			GPS Latitude/Longitude	
				Start	End
Item	Encroachments			37.894258 °	37.894258 °
				-121.329247 °	-121.329247 °
DWR ID	DWR_RD0524_01_s _ 2012_111				
Action/Comments					
Tree or limb Inspector Comments: Dead tree at landside toe should be removed from levee toe.

Looking west at dead tree at landside toe.

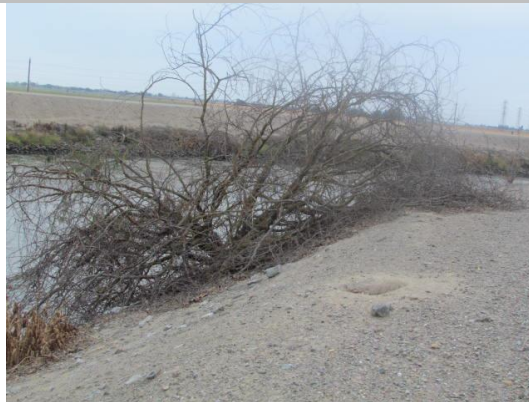
Photo 1 of 1 : SP_2015_RD0524_107_102_20150309_00105.jpg

LM Start	4.52	Rating **	M	Issue No.	102
LM End	4.52	Issue Type +	En	Location *	WS
Category	Earthen Levee			GPS Latitude/Longitude	
				Start	End
Item	Encroachments			37.892368 °	37.892368 °
				-121.328200 °	-121.328200 °
DWR ID	DWR_RD0524_01_s_2012_102				
Action/Comments					
Prunings

Looking southeast at dead tree on waterside slope.

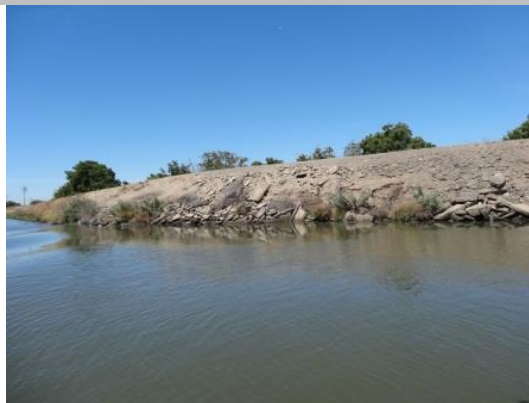
Photo 1 of 1 : SP_2015_RD0524_107_79_20150309_00091.jpg

LM Start	4.53	Rating **	U	Issue No.	79
LM End	4.53	Issue Type +	Ma	Location *	WS
Category	Supplemental			GPS Latitude/Longitude	
				Start	End
Item	DWR Erosion Survey			37.892230 °	37.892230 °
				-121.327930 °	-121.327930 °
DWR ID	DWR_RD0524_01_s _ 2015_79				
Action/Comments					
Inspector Comments: 6/19/2014: No significant change observed. 08/13/2013: No significant change observed. 08/07/2012: The erosion is located at the inside of a river bend. Site is covered with broken concrete blocks and other debris. [2014 Site ID:RD0524U01RM45.07]

Downstream view of the erosion site.

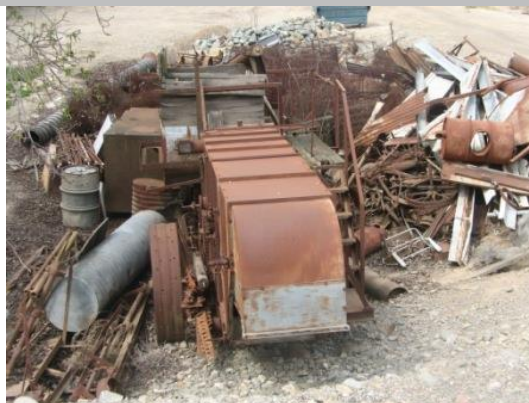
Photo 1 of 1 : SP_2015_RD0524_107_66_20150309_00081.jpg

LM Start	4.60	Rating **	M	Issue No.	66
LM End	4.60	Issue Type +	Ma	Location *	LS
Category	Earthen Levee			GPS Latitude/Longitude	
				Start	End
Item	Encroachments			37.891365 °	37.891365 °
				-121.328633 °	-121.328633 °
DWR ID	DWR_RD0524_01_s _ 2012_66				
Action/Comments					
Garbage

Garbage at landward toe next to ramp at LM 4.64

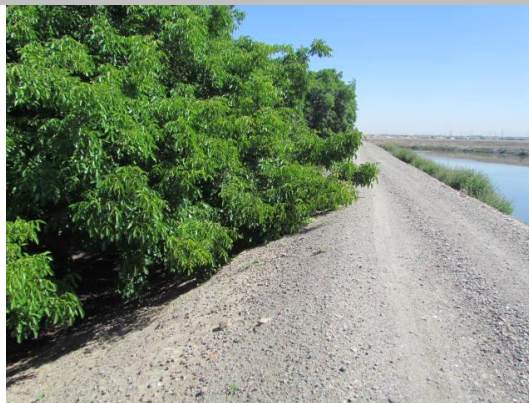
Photo 1 of 1 : SP_2015_RD0524_107_113_20150309_00117.jpg

Looking north at dense trees on landside slope.

LM Start	4.63	Rating **	A/W	Issue No.	113
LM End	4.63	Issue Type +	Ma	Location *	LS
Category	Earthen Levee			GPS Latitude/Longitude	
				Start	End
Item	Trim / Thin Trees			37.890973 °	37.890973 °
				-121.328970 °	-121.328970 °
DWR ID	DWR_RD0524_01_s _ 2012_113				
Action/Comments					
Trim trees to at least five feet above ground level.

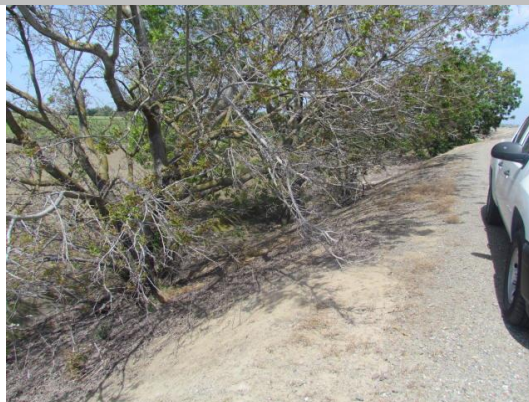
Photo 1 of 1 : SP_2015_RD0524_107_84_20150424_00231.jpg

Looking northeast at untrimmed trees on landward slope.

LM Start	4.90	Rating **	U	Issue No.	84
LM End	4.93	Issue Type +	Ma	Location *	LS
Category	Earthen Levee			GPS Latitude/Longitude	
				Start	End
Item	Trim / Thin Trees			37.887655 °	37.887277 °
				-121.331202 °	-121.331609 °
DWR ID	DWR_RD0524_01_s_2012_84				
Action/Comments					
Trim trees to at least five feet above ground level.

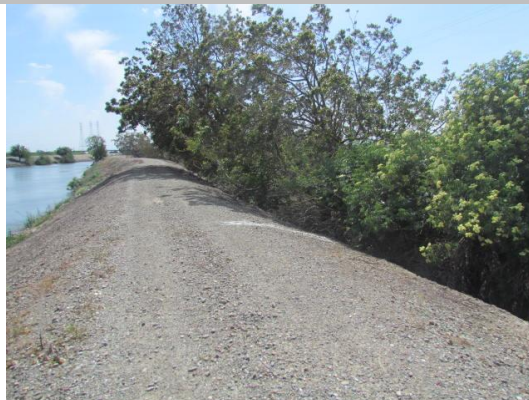
Photo 1 of 1 : SP_2015_RD0524_107_71_20150424_00232.jpg

LM Start	5.05	Rating **	M	Issue No.	71
LM End	5.07	Issue Type +	Ma	Location *	LS
Category	Earthen Levee			GPS Latitude/Longitude	
				Start	End
Item	Trim / Thin Trees			37.885613 °	37.885286 °
				-121.332139 °	-121.332167 °
DWR ID	DWR_RD0524_01_s_2012_71				
Action/Comments					
Trim trees to at least five feet above ground level.

Looking south at untrimmed trees on landward slope.

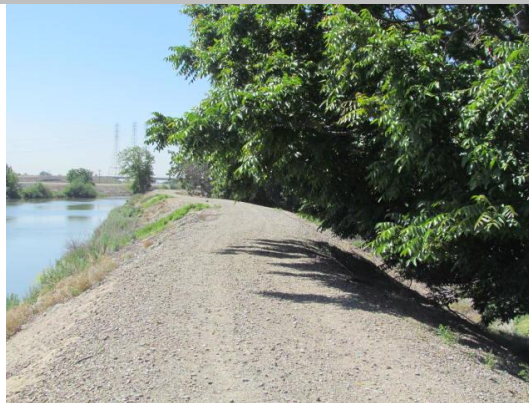
Photo 1 of 1 : SP_2015_RD0524_107_68_20150309_00082.jpg

LM Start	5.07	Rating **	U	Issue No.	68
LM End	5.07	Issue Type +	Ma	Location *	LS
Category	Earthen Levee			GPS Latitude/Longitude	
				Start	End
Item	Trim / Thin Trees			37.885400 °	37.885400 °
				-121.332153 °	-121.332153 °
DWR ID	DWR_RD0524_01_s _ 2012_68				
Action/Comments					
Trim trees over roadway to at least 12 feet above ground level.

Looking south at overhanging trees.

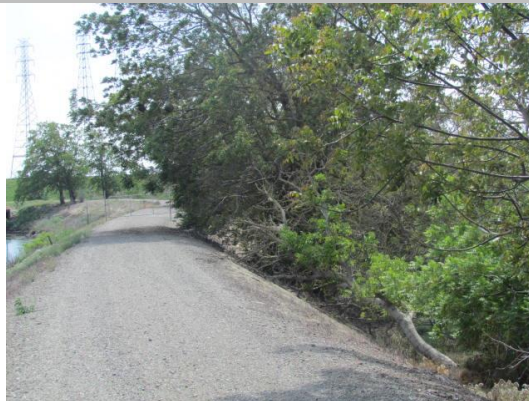
Photo 1 of 1 : SP_2015_RD0524_107_932_20150424_00234.jpg

LM Start	5.38	Rating **	M	Issue No.	932
LM End	5.41	Issue Type +	Ma	Location *	LS
Category	Earthen Levee			GPS Latitude/Longitude	
				Start	End
Item	Trim / Thin Trees			37.880945 °	37.880522 °
				-121.332837 °	-121.332918 °
DWR ID	DWR_RD0524_01_s _ 2012_932				
Action/Comments					
Trim trees to at least five feet above ground level.

Looking south at untrimmed trees on landward slope and toe.

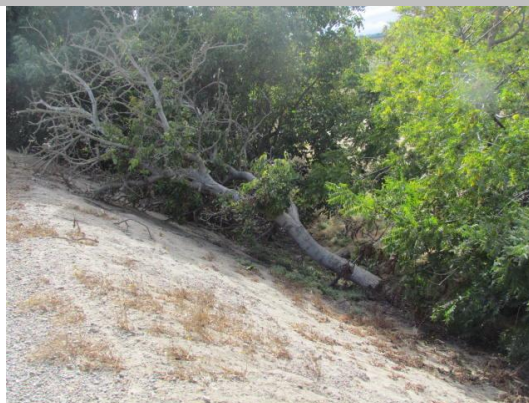
Photo 1 of 1 : SP_2015_RD0524_107_178_20150309_00145.jpg

LM Start	5.39	Rating **	M	Issue No.	178
LM End	5.39	Issue Type +	Ma	Location *	N/A
Category	Earthen Levee			GPS Latitude/Longitude	
				Start	End
Item	Encroachments			37.880806 °	37.880806 °
				-121.332833 °	-121.332833 °
DWR ID	DWR_RD0524_01_f _ 2014_178				
Action/Comments					
Tree or limb					
Inspector Comments: Downed tree on landward toe.

Looking south at downed tree on landward slope.

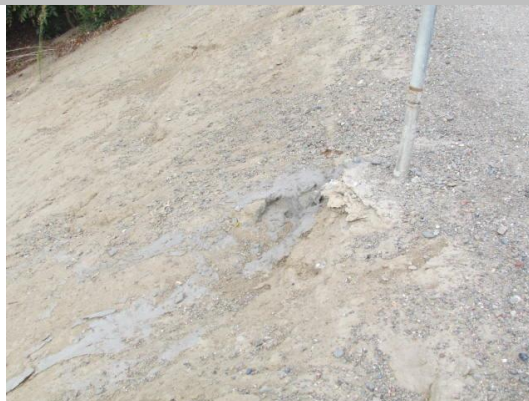
Photo 1 of 2 : SP_2015_RD0524_107_931_20150309_00169.jpg

LM Start	5.41	Rating **	A/W	Issue No.	931
LM End	5.41	Issue Type +	Ma	Location *	LS
Category	Earthen Levee			GPS Latitude/Longitude	
				Start	End
Item	Animal Control			37.880575 °	37.880575 °
				-121.332890 °	-121.332890 °
DWR ID	DWR_RD0524_01_s _ 2012_931				
Action/Comments					
Exterminate rodents and backfill and compact or grout burrows. Inspector Comments: LMA grouted rodent holes.

Looking north at typical view of grouted rodent holes on landward shoulder and slope.

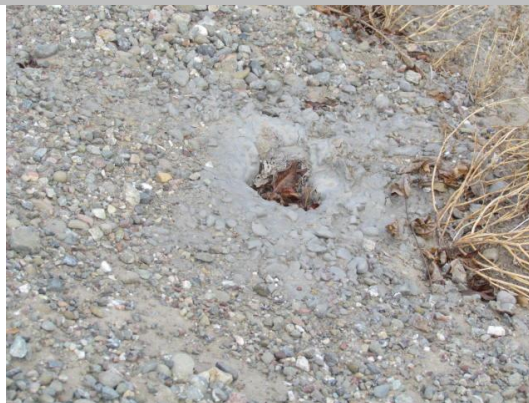
Photo 2 of 2 : SP_2015_RD0524_107_931_20150309_00170.jpg

LM Start	5.41	Rating **	A/W	Issue No.	931 (cont)
LM End	5.41	Issue Type +	Ma	Location *	LS
Category	Earthen Levee			GPS Latitude/Longitude	
				Start	End
Item	Animal Control			37.880575 °	37.880575 °
				-121.332890 °	-121.332890 °
DWR ID	DWR_RD0524_01_s_2012_931				
Action/Comments					
Exterminate rodents and backfill and compact or grout burrows. Inspector Comments: LMA grouted rodent holes.

Looking north at typical view of grouted rodent holes on waterward slope.

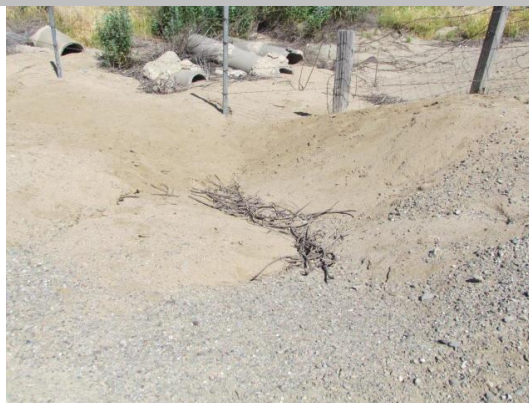
Photo 1 of 3 : SP_2015_RD0524_107_118_20150309_00119.jpg

LM Start	5.42	Rating **	M	Issue No.	118
LM End	5.42	Issue Type +	Ma	Location *	LS
Category	Earthen Levee			GPS Latitude/Longitude	
				Start	End
Item	Slope Stability			37.880323 °	37.880323 °
				-121.332968 °	-121.332968 °
DWR ID	DWR_RD0524_01_s_2012_118				
Action/Comments					
Repair slope instability.					
Inspector Comments: Slope damage caused by human activity.

Looking west at slope damage on landside slope.

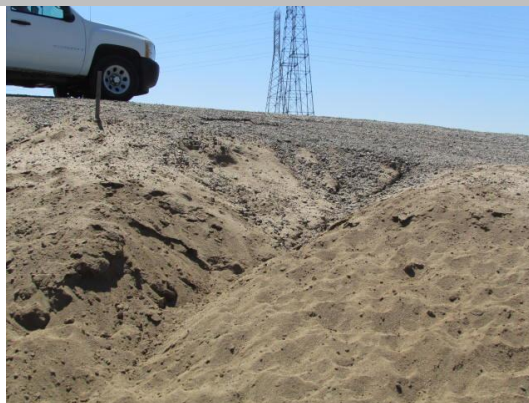
Photo 2 of 3 : SP_2015_RD0524_107_118_20150309_00120.jpg

LM Start	5.42	Rating **	M	Issue No.	118 (cont)
LM End	5.42	Issue Type +	Ma	Location *	LS

Looking southeast at damaged slope.

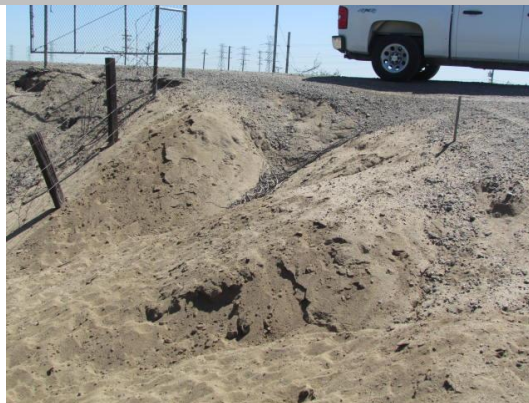
Photo 3 of 3 : SP_2015_RD0524_107_118_20150309_00121.jpg

LM Start	5.42	Rating **	M	Issue No.	118 (cont)
LM End	5.42	Issue Type +	Ma	Location *	LS
Category	Earthen Levee			GPS Latitude/Longitude	
				Start	End
Item	Slope Stability			37.880323 °	37.880323 °
				-121.332968 °	-121.332968 °
DWR ID	DWR_RD0524_01_s _ 2012_118				
Action/Comments					
Repair slope instability.					
Inspector Comments: Slope damage caused by human activity.

Looking east at slope caving on landside slope.

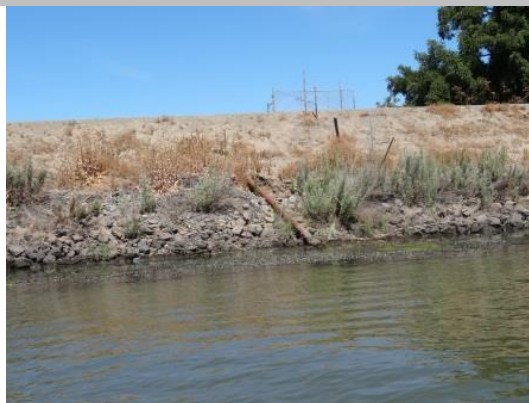
Photo 1 of 1 : SP_2015_RD0524_107_125_20150309_00126.jpg

LM Start	5.43	Rating **	U	Issue No.	125
LM End	5.43	Issue Type +	Ma	Location *	WS
Category	Supplemental			GPS Latitude/Longitude	
				Start	End
Item	DWR Erosion Survey			37.880320 °	37.880320 °
				-121.333266 °	-121.333266 °
DWR ID	DWR_RD0524_01_s _ 2015_125				
Action/Comments					
Inspector Comments: 6/19/2014: No significant change observed. 08/13/2013: The erosion seems to be getting worse. More material sloughing visible. 08/07/2012: The erosion is underneath an irrigation pipe. The likely cause of the erosion is the pipe leakage. [2014 Site ID:RD0524U01RM45.97]

Close view of the erosion and the pipe.

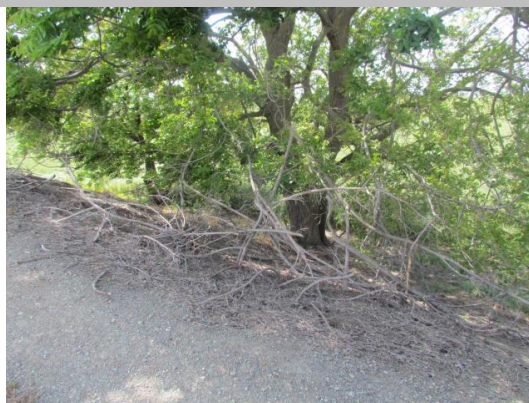
Photo 1 of 1 : SP_2015_RD0524_107_73_20150424_00235.jpg

LM Start	5.44	Rating **	M	Issue No.	73
LM End	5.44	Issue Type +	Ma	Location *	LS
Category	Earthen Levee			GPS Latitude/Longitude	
				Start	End
Item	Trim / Thin Trees			37.880085 °	37.880085 °
				-121.333045 °	-121.333045 °
DWR ID	DWR_RD0524_01_s _ 2012_73				
Action/Comments					
Trim trees to at least five feet above ground level.

Looking east at untrimmed trees on landward slope.

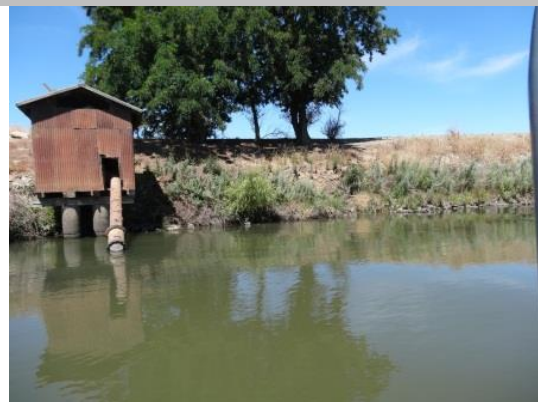
Photo 1 of 1 : SP_2015_RD0524_107_126_20150309_00127.jpg

LM Start	5.53	Rating **	M	Issue No.	126
LM End	5.53	Issue Type +	Ma	Location *	WS
Category	Supplemental			GPS Latitude/Longitude	
				Start	End
Item	DWR Erosion Survey			37.878920 °	37.878920 °
				-121.332670 °	-121.332670 °
DWR ID	DWR_RD0524_01_s _ 2015_126				
Action/Comments					
Inspector Comments: 6/19/2014: No significant change observed. 08/13/2013: Larger trees are at the levee shoulder, and an irrigation pump station is next to the erosion site. [2014 Site ID:RD0524U01RM46.06]

Front view of the erosion.

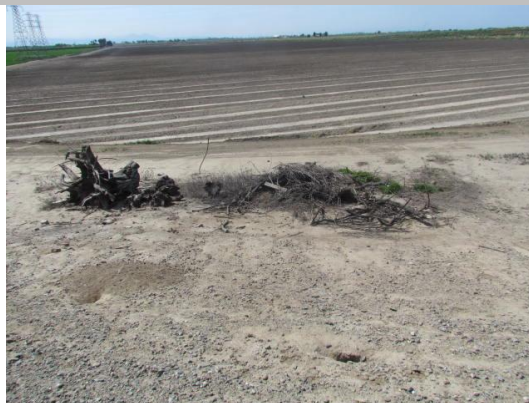
Photo 1 of 1 : SP_2015_RD0524_107_267_20150424_00236.jpg

LM Start	5.79	Rating **	M	Issue No.	267
LM End	5.79	Issue Type +	Ma	Location *	LS
Category	Earthen Levee			GPS Latitude/Longitude	
				Start	End
Item	Encroachments			37.875328 °	37.875328 °
				-121.333050 °	-121.333050 °
DWR ID	DWR_RD0524_01_s_2012_267				
Action/Comments					
Prunings					
Inspector Comments: Prunings at landside toe should be burned or removed.

Looking east at pruning piles at landward toe and berm.

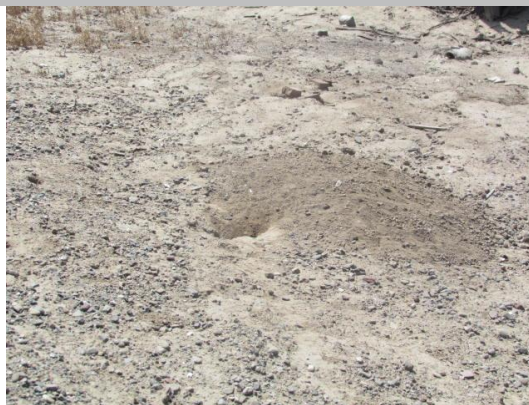
Photo 1 of 2 : SP_2015_RD0524_107_197_20150424_00237.jpg

LM Start	5.79	Rating **	M	Issue No.	197
LM End	5.79	Issue Type +	Ma	Location *	LS
Category	Earthen Levee			GPS Latitude/Longitude	
				Start	End
Item	Animal Control			37.875310 °	37.875310 °
				-121.333065 °	-121.333065 °
DWR ID	DWR_RD0524_01_s_2015_197				
Action/Comments					
Exterminate rodents and backfill and compact or grout burrows. Inspector Comments: Several rodent holes on landward slope and levee crown.

Looking north at typical view of rodent holes on landward slope.

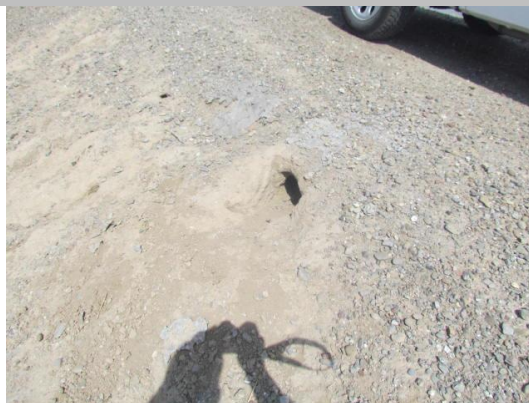
Photo 2 of 2 : SP_2015_RD0524_107_197_20150424_00238.jpg

LM Start	5.79	Rating **	M	Issue No.	197 (cont)
LM End	5.79	Issue Type +	Ma	Location *	LS

Looking southwest at typical view of rodent hole at landward shoulder.

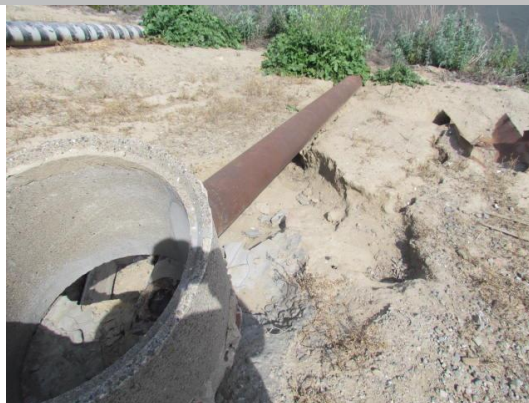
Photo 2 of 3 : SP_2015_RD0524_107_198_20150424_00240.jpg

LM Start	5.81	Rating **	U	Issue No.	198 (cont)
LM End	5.81	Issue Type +	Ma	Location *	WS
Category	Interior Drainage & Piping Systems			GPS Latitude/Longitude	
				Start	End
Item	Erosion Areas			37.874950 °	37.874950 °
				-121.333273 °	-121.333273 °
DWR ID	DWR_RD0524_01_s _ 2015_198				
Action/Comments					
Inspector Comments: Large erosion around irrigation pipe on waterward slope.

Looking east at erosion around irrigation pipe.

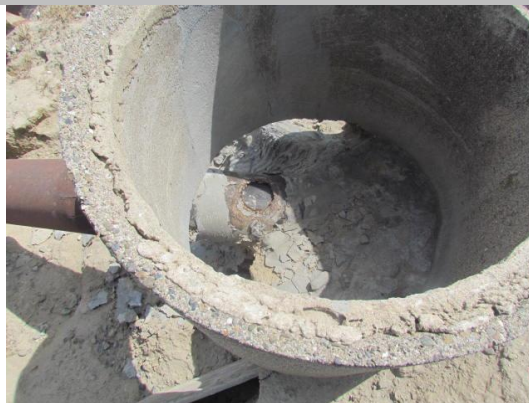
Photo 3 of 3 : SP_2015_RD0524_107_198_20150424_00241.jpg

LM Start	5.81	Rating **	U	Issue No.	198 (cont)
LM End	5.81	Issue Type +	Ma	Location *	WS

Looking at erosion around pipe inside concrete collar.

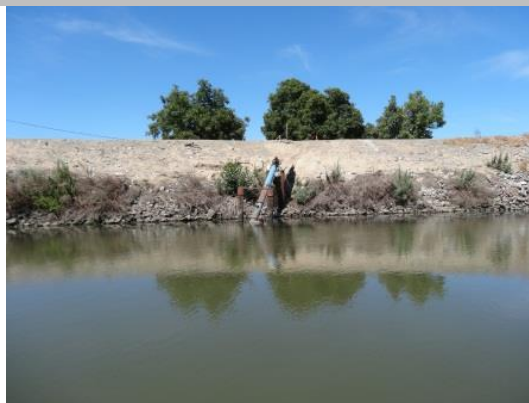
Photo 1 of 1 : SP_2015_RD0524_107_128_20150309_00128.jpg

LM Start	5.86	Rating **	U	Issue No.	128
LM End	5.86	Issue Type +	Ma	Location *	WS
Category	Supplemental			GPS Latitude/Longitude	
				Start	End
Item	DWR Erosion Survey			37.874370 °	37.874370 °
				-121.332850 °	-121.332850 °
DWR ID	DWR_RD0524_01_s _ 2015_128				
Action/Comments					
Inspector Comments: 06/19/2014: No significant change observed. 08/13/2013: No significant change observed. 08/07/2012: The erosion is near a water-intake structure. Pipe leakage likely caused the erosion. [2014 Site ID:RD0524U01RM46.39]

Front view of the site.

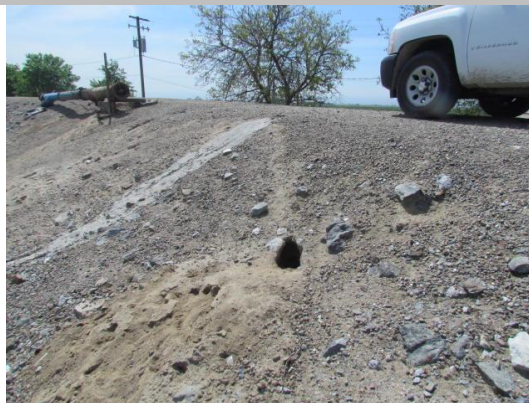
Photo 2 of 2 : SP_2015_RD0524_107_75_20150309_00087.jpg

LM Start	5.86	Rating **	M	Issue No.	75
LM End	5.88	Issue Type +	Ma	Location *	WS
Category	Earthen Levee			GPS Latitude/Longitude	
				Start	End
Item	Animal Control			37.874240 °	37.874002 °
				-121.333187 °	-121.333027 °
DWR ID	DWR_RD0524_01_s _ 2012_75				
Action/Comments					
No rodents visible, but rodent burrows visible; need to backfill and compact or grout burrows. Inspector Comments: District has grouted rodent holes, but other rodent holes have appeared.

Looking southwest at typical rodent holes on waterward slope.

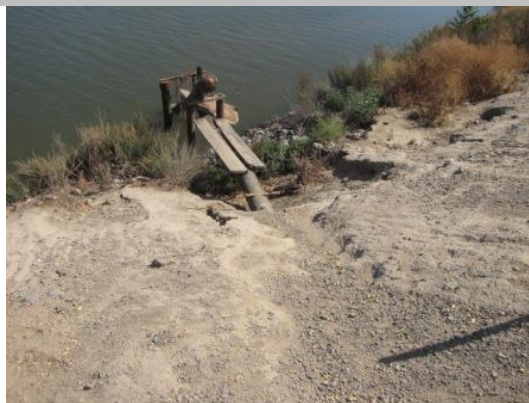
Photo 1 of 3 : SP_2015_RD0524_107_74_20150309_00083.jpg

LM Start	5.86	Rating **	M	Issue No.	74
LM End	5.87	Issue Type +	Ma	Location *	WS
Category	Earthen Levee			GPS Latitude/Longitude	
				Start	End
Item	Erosion / Bank Caving			37.874240 °	37.874165 °
				-121.333185 °	-121.333155 °
DWR ID	DWR_RD0524_01_s _ 2012_74				
Action/Comments					
Note and monitor erosion site.					
Inspector Comments: Erosion on landward slope around intake pipe.

Looking southeast at erosion around pipe.

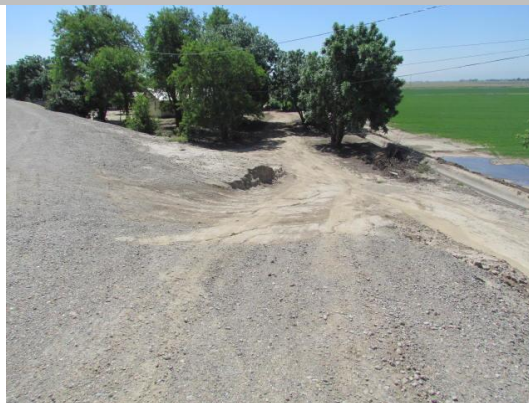
Photo 2 of 2 : SP_2015_RD0524_107_119_20150309_00123.jpg

LM Start	5.89	Rating **	U	Issue No.	119
LM End	5.89	Issue Type +	Ma	Location *	LS
Category	Earthen Levee			GPS Latitude/Longitude	
				Start	End
Item	Slope Stability			37.873893 °	37.873893 °
				-121.332978 °	-121.332978 °
DWR ID	DWR_RD0524_01_s _ 2012_119				
Action/Comments					
Repair the levee slope damaged by vehicle traffic and prevent access where possible.					
Inspector Comments: Landowner is using damaged area as a ramp.

Looking southwest at damaged slope and ramp on landside slope.

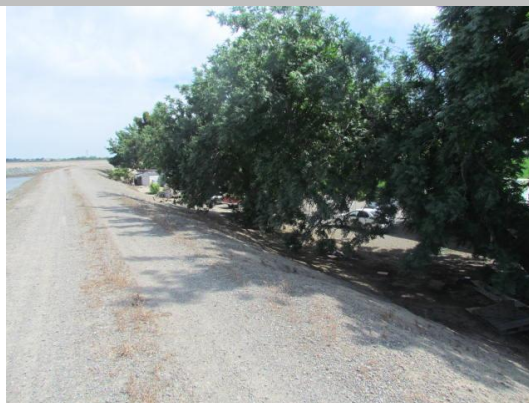
Photo 1 of 1 : SP_2015_RD0524_107_120_20150424_00242.jpg

LM Start	5.96	Rating **	M	Issue No.	120
LM End	5.96	Issue Type +	Ma	Location *	LS
Category	Earthen Levee			GPS Latitude/Longitude	
				Start	End
Item	Trim / Thin Trees			37.873347 °	37.873347 °
				-121.332028 °	-121.332028 °
DWR ID	DWR_RD0524_01_s _ 2012_120				
Action/Comments					
Trim trees to at least five feet above ground level.

Looking south at untrimmed trees on landward slope and toe.

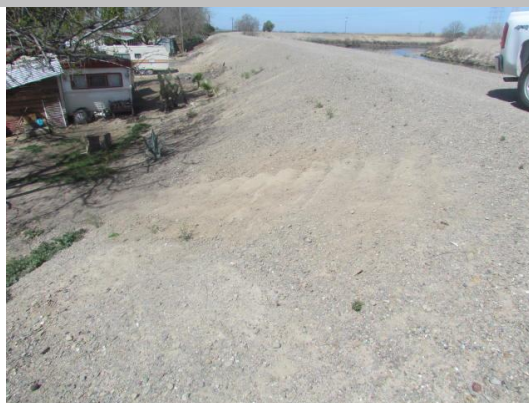
Photo 1 of 1 : SP_2015_RD0524_107_933_20150309_00171.jpg

LM Start	6.00	Rating **	M	Issue No.	933
LM End	6.00	Issue Type +	Ma	Location *	LS
Category	Earthen Levee			GPS Latitude/Longitude	
				Start	End
Item	Slope Stability			37.873047 °	37.873047 °
				-121.331408 °	-121.331408 °
DWR ID	DWR_RD0524_01_s _ 2012_933				
Action/Comments					
Repair the levee slope damaged by foot traffic and prevent access where possible.					
Inspector Comments: Landowner cut steps into landside slope.

Looking north at steps cut into landward slope.

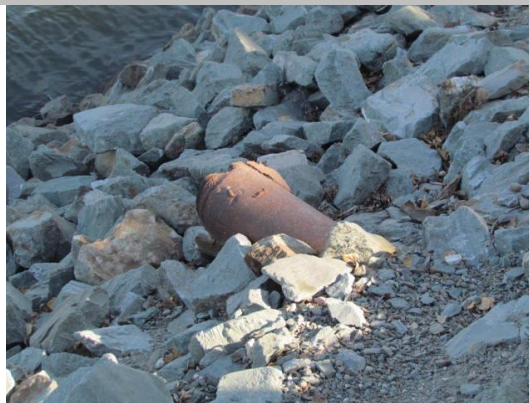
Photo 1 of 1 : SP_2015_RD0524_107_268_20150309_00163.jpg

LM Start	6.15	Rating **	M	Issue No.	268
LM End	6.15	Issue Type +	Ma	Location *	WS
Category	Earthen Levee			GPS Latitude/Longitude	
				Start	End
Item	Encroachments			37.871137 °	37.871137 °
				-121.330138 °	-121.330138 °
DWR ID	DWR_RD0524_01_s _ 2012_268				
Action/Comments					
Pipe					
Inspector Comments: Open abandoned 10" pipe on waterside slope below flood elevation. Pipe should be removed or properly abandoned.

Looking southeast at abandoned pipe on waterside slope.

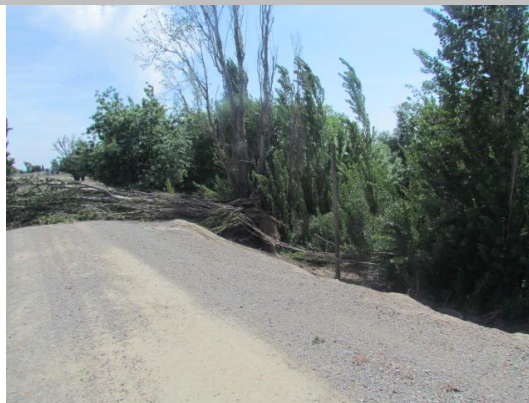
Photo 1 of 2 : SP_2015_RD0524_107_81_20150424_00243.jpg

LM Start	6.15	Rating **	U	Issue No.	81
LM End	6.15	Issue Type +	Ma	Location *	LS
Category	Earthen Levee			GPS Latitude/Longitude	
				Start	End
Item	Encroachments			37.871097 °	37.871097 °
				-121.330100 °	-121.330100 °
DWR ID	DWR_RD0524_01_s _ 2015_81				
Action/Comments					
Tree or limb Inspector Comments: Large tree fallen across levee crown blocking access.

Looking southwest at large tree across levee crown.

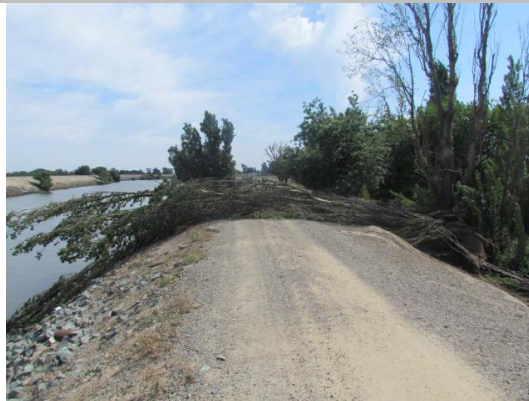
Photo 2 of 2 : SP_2015_RD0524_107_81_20150424_00244.jpg

LM Start	6.15	Rating **	U	Issue No.	81 (cont)	
LM End	6.15	Issue Type +	Ma	Location *	LS	
Category	Earthen Levee			GPS Latitude/Longitude		
				Start		End
Item	Encroachments			37.871097 °		37.871097 °
				-121.330100 °		-121.330100 °
DWR ID	DWR_RD0524_01_s _ 2015_81					
Action/Comments						
Tree or limb						
Inspector Comments: Large tree fallen across levee crown blocking access.

Looking south at large tree across levee crown.

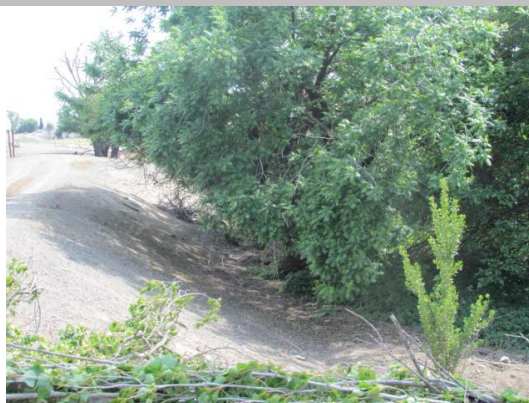
Photo 1 of 1 : SP_2015_RD0524_107_98_20150424_00245.jpg

LM Start	6.17	Rating **	M	Issue No.	98
LM End	6.17	Issue Type +	Ma	Location *	LS
Category	Earthen Levee			GPS Latitude/Longitude	
				Start	End
Item	Trim / Thin Trees			37.870842 °	37.870842 °
				-121.330000 °	-121.330000 °
DWR ID	DWR_RD0524_01_s _ 2012_98				
Action/Comments					
Trim trees to at least five feet above ground level.

Looking southeast at untrimmed trees at landward toe.
